## IMPORTANT NOTICE

It has recently come to our attention that the one of our products, the **NCVT-1 NONCONTACT VOLTAGE TESTER**, has a potential safety issue that Klein Tools would like to rectify. The on/off button of the NCVT-1 is intended to be pressed down and then released. If the button remains depressed during the power on or power off cycle, the tip of the tool remains illuminated in green, indicating the tool is “ready to detect voltage,” when it is not.

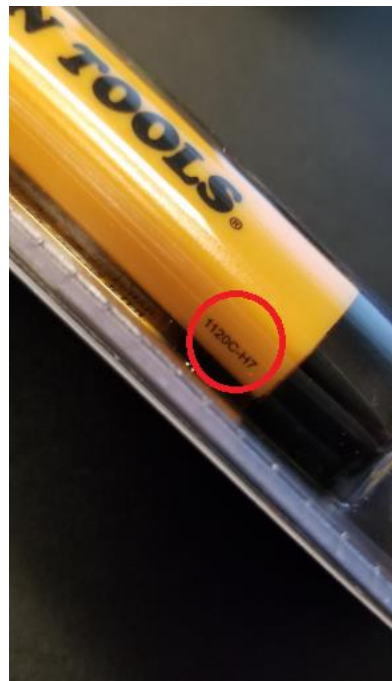
1. Immediately stop all sales of the NCVT-1 bearing date codes ending H7, including online sales. The date code can be seen on the right side of the product in packaging, as pictured on the right.
2. Hold your inventory of NCVT-1 until further notice. Instructions for return of NCVT-1 products to Klein Tools will follow shortly.
3. Identify purchasers of products via any records you have and forward them to [ncvt1support@kleintools.com](mailto:ncvt1support@kleintools.com) so that we may contact them to issue a replacement.
